**State of Louisiana  
Department of Coastal Protection and  
Restoration  
Operations Division**

## **2012 Annual Inspection Report**

### **DELTA WIDE CREVASSES (MR-09)**

October 3, 2012  
Plaquemines Parish

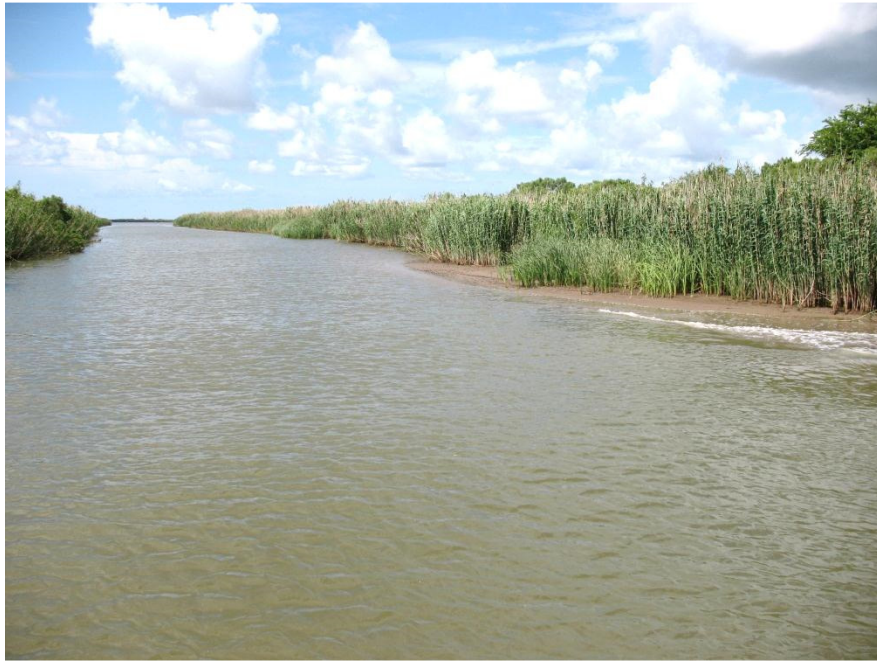
- E. Crevasse No. 12 (1999): (2,000 ft. X 75 ft. X -8.0 ft. NAVD 88) This crevasse has silted in on the right bank and is forming a channel ranging from 4'-8' deep. Mudflats spread across the receiving bay indicating development of new land

Crevasse No. 12 (View 1) Looking into crevasse from South East Pass.

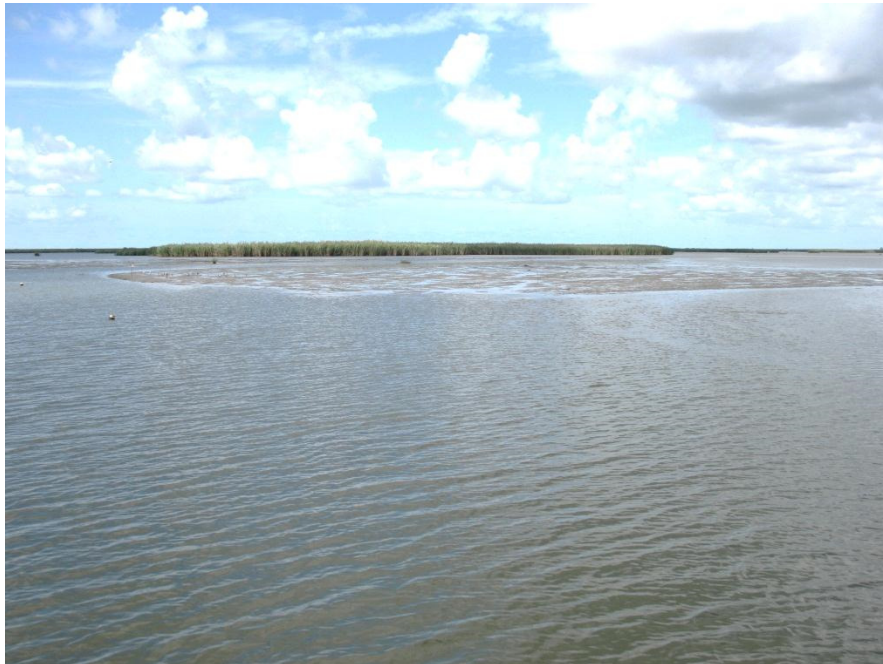
Crevasse No. 12 (View 2) Looking west. Spoil area in center of view.

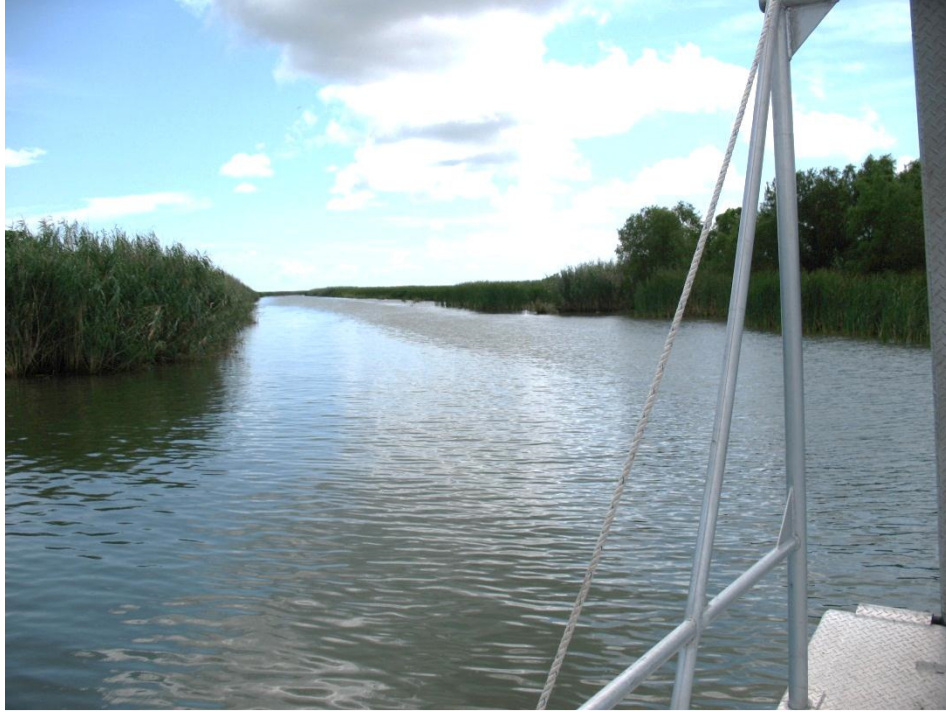
- D. Crevasse No. 11 (1999): (2,600 ft. X 100 ft. X -8.0 ft. NAVD 88) This re-dredged crevasse (1999) is maintaining a good flow throughout its length. Soundings indicate that it has maintained 5'-7' depth throughout the channel. The low water levels in the river have allowed more vegetation growth on sediment deposits. Wild rice is now growing in the interior receiving bay.

Crevasse No. 11. (View 1) Looking back to Pass a Loutre. Crevasse has maintained its constructed width throughout.

Crevasse # 11	Very Good	None	2,600 ft X 100 ft by -8.0' NAVD 88	Appendix B	<4 ft at the inlet, which drops to 8 ft and rises to 5-6 ft about 100 yards in.. The crevasse was 3' at the terminus. The channel is forming on the left side with SAV present on the right side. Wild rice growing throughout receiving bay.
Crevasse # 12	Very Good	None	2,000 ft X 75 ft by -8.0' NAVD 88	Appendix B	Currents are moderate to swift through this crevasse, despite it being located off of the main channel. Soundings read 8' at the inlet, 5'-6' halfway through, and <4' at the terminus. Right side of the crevasse is beginning to silt in..
Crevasse # 81	Poor	None	1,200 ft X 100 ft by -8.0' NAVD 88	Appendix B	This crevasse is located on the south bank of Baptiste Collette just off of the Miss. River. Due to its location, it is receiving strong current and heavy sediment loads. The dredge spoil has vegetated very nicely; however, it's location causes it to shoal at the inlet (3'-4' depth) during the first high river and renders it inefficient for the long term.

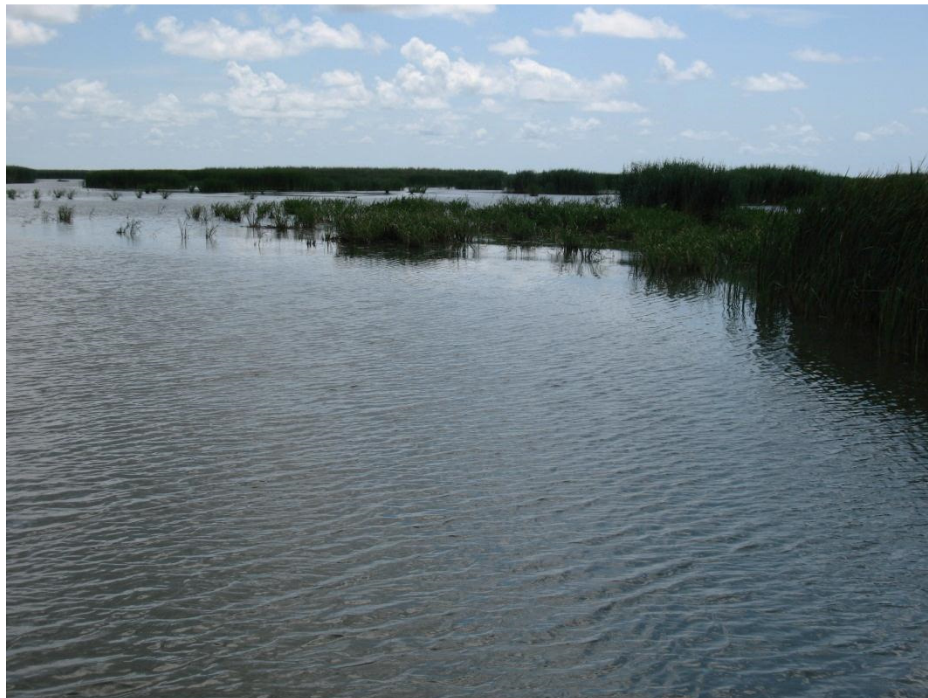
Crevasse No. 11. (View 2) Vegetated crevasse dredging spoil in bay area, foreground.

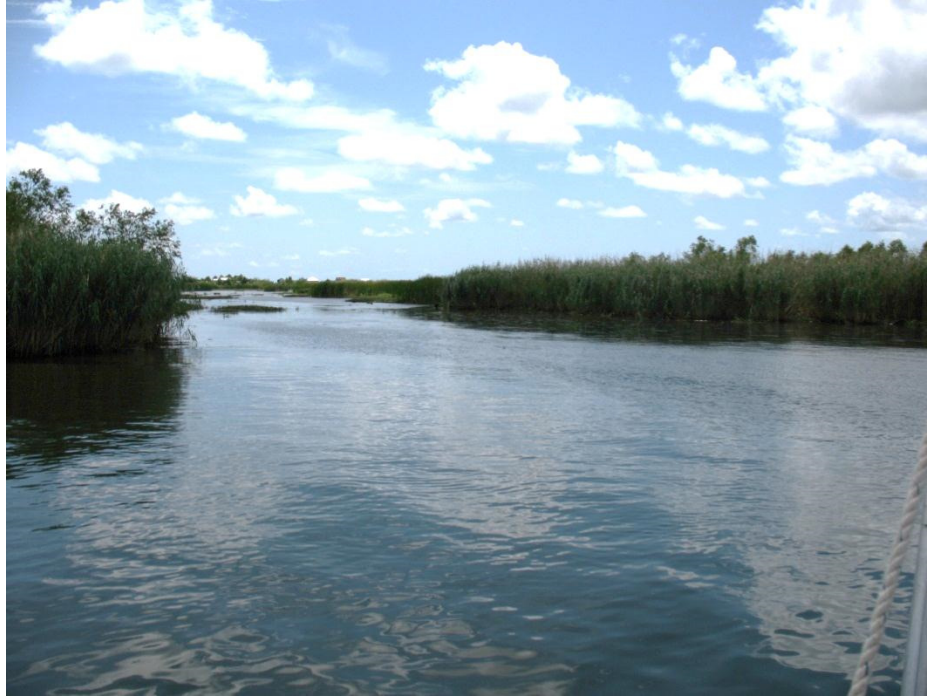
- A. Crevasse No. NC-1 (2005): (1,000 ft. X 100 ft. X -8.0 ft. NAVD 88) This crevasse appears to be in good condition. Soundings indicate that it has retained slightly more than half of its originally constructed depth. The interior indicates that river water is flowing very well through the channel carrying large amounts of sediment, and the receiving bay is heavily vegetated. SAV's densely populate the spoil islands.
- B. Crevasse No. NC-3 (2005): (1,400 ft. X 100 ft. X -8.0 ft. NAVD 88) This is the second of the two new crevasses and the only one on South Pass. Our soundings show that the crevasse is maintaining its original depth throughout its channel length and the spoil from the crevasse

Crevasse No. NC-1. (View 1) Looking into Receiving Bay.

Item	Condition	Physical Damage	Dimensions	Photo	Observations and Remarks
Crevasse # NC-1	Good	None	1,000 ft X 100 ft by -8.0' NAVD 88	Appendix B	This new crevasse (2005) appears to be in good condition. Soundings read 4' at the inlet and 4' at the terminus. The spoil from the dredging of the crevasse is heavily vegetated throughout the deposited bay area (roseau cane patches)
Crevasse # NC-3	Excellent	None	1,400 ft X 100 ft by -8.0' NAVD 88	Appendix B	This new crevasse (2005) off of South Pass is functioning very well, seems to be flowing swiftly. This crevasse maintains a -10'+ at inlet and 8.5' at the terminus. The interior bay is heavily silted and full of roseau cane.
Crevasse # 9	Very Good	None	2,200 ft X 75 ft by -8.0' NAVD 88	Appendix B	Good flow is being maintained by this dog-leg shaped crevasse. 6' at inlet, sloping to 8'. The water depth hovered between 5'-6' throughout the channel. Vegetation includes cut grass and roseau cane

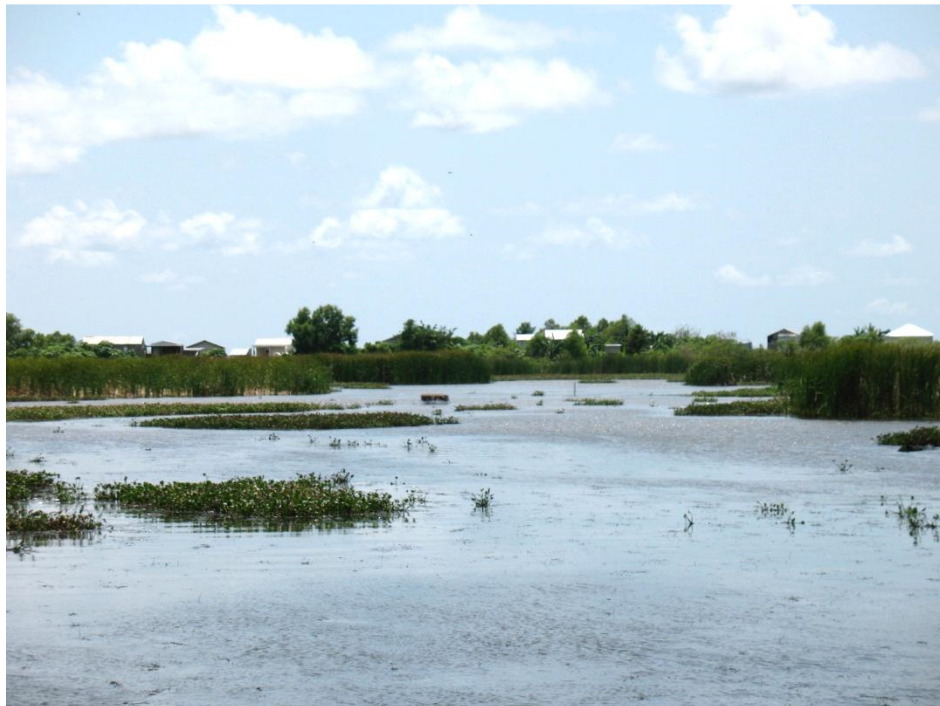
Crevasse No. NC-1. (View 2) Vegetated spoil deposition in inside bay area.

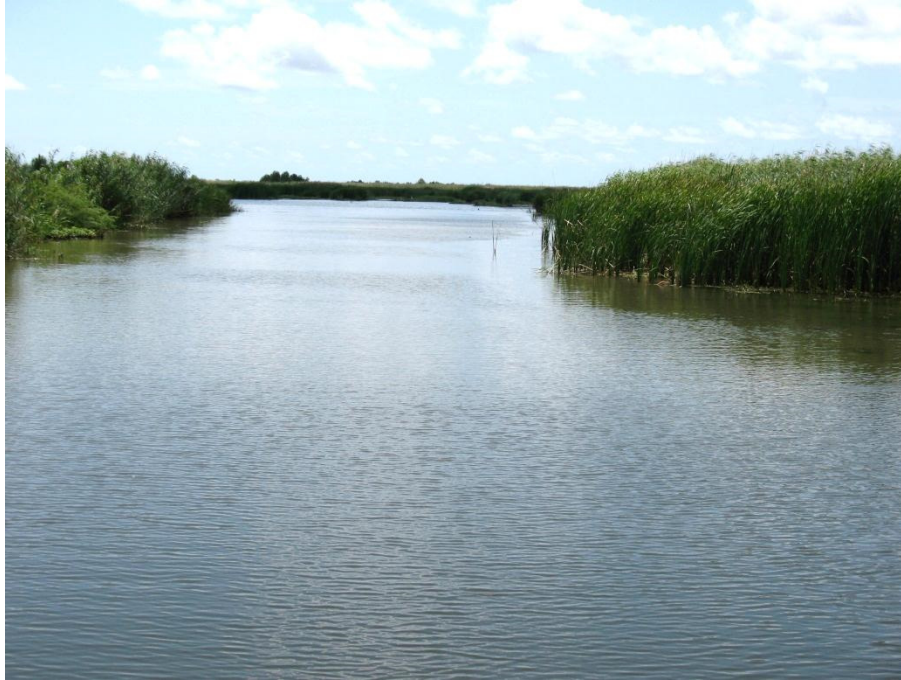
- C. Crevasse No. 9 (1999): (2,200 ft. X 75 ft. X -8.0 ft. NAVD 88) Dog-leg shaped crevasse. Soundings indicate that this crevasse is maintaining a 5'-6' depth. The spoil deposition from this cut is very heavily vegetated with cut grass and Roseau cane.

Crevasse No. 9. (View 1) From Pass-A-Loutre looking south into the crevasse.

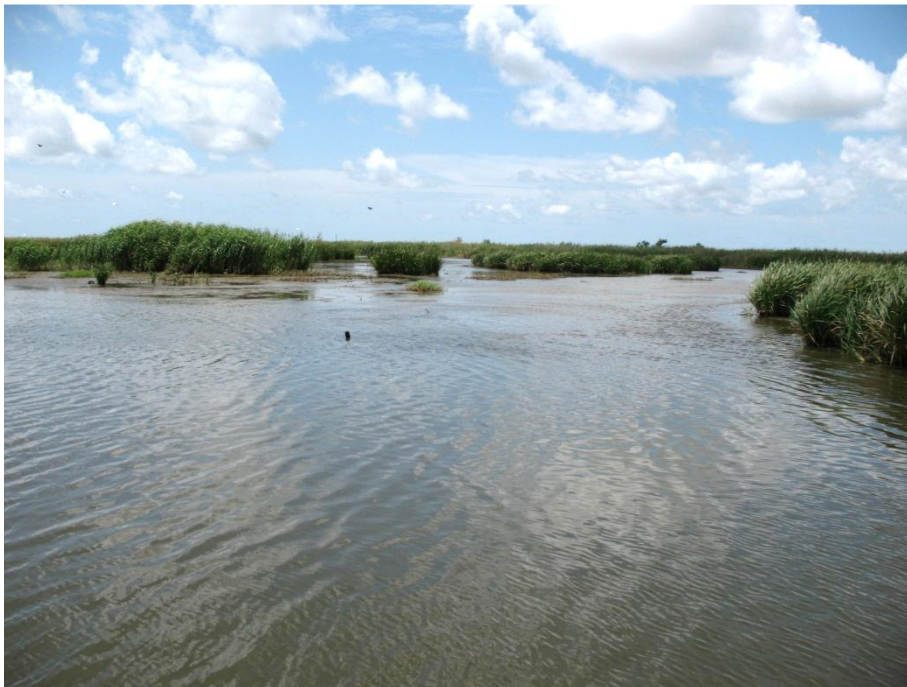
Crevasse No. 9. (View 2) Crevasse end looking at spoil area vegetation sediment deposits from the recent high river.

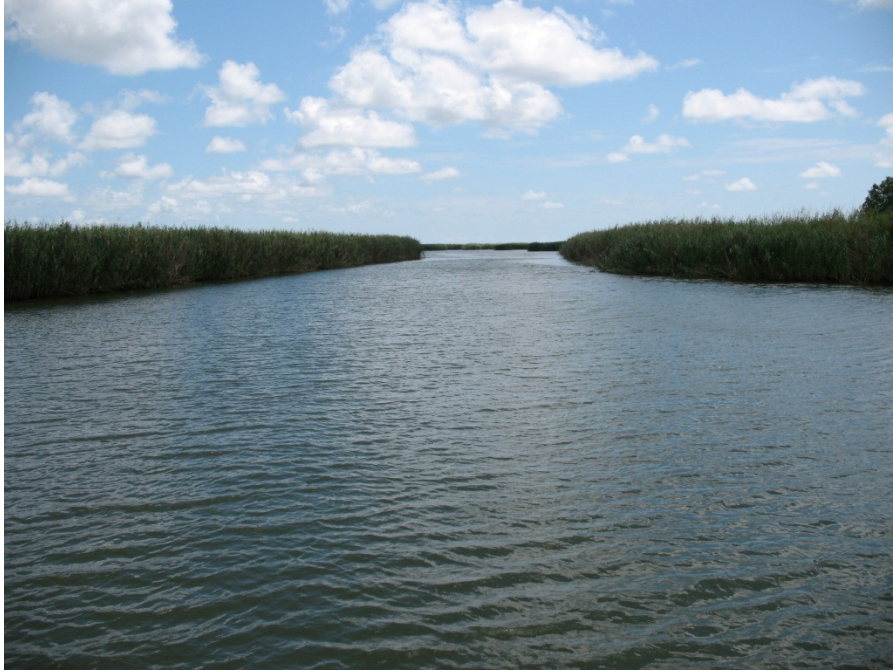
Crevasse No. NC-3. (View 1) Looking into crevasse from South Pass showing heavy vegetation on both banks.

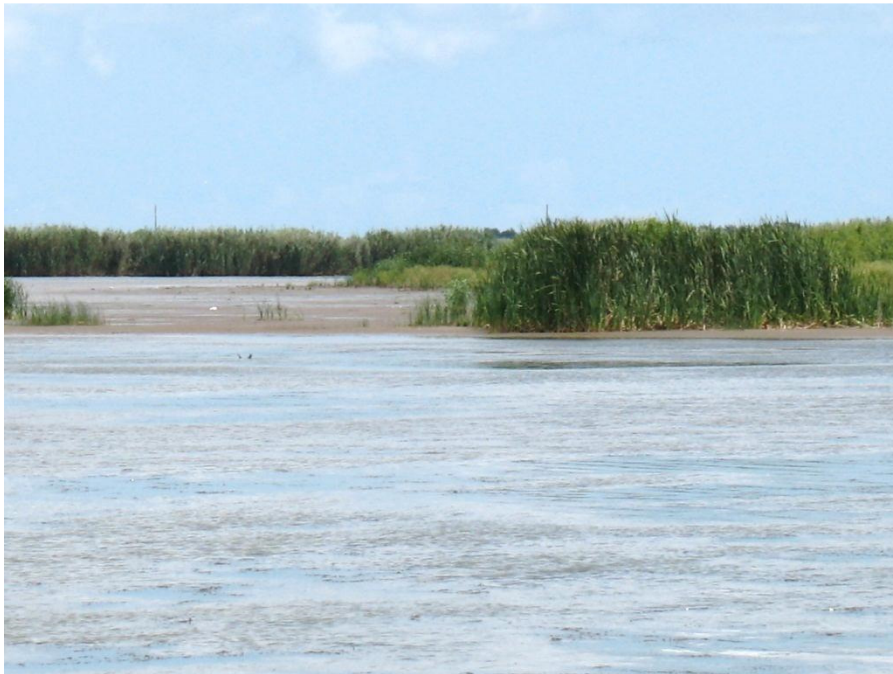
Crevasse No. NC-3. (View 2) Crevasse terminus looking east into open pond area. Notice shallow depth of water in center.

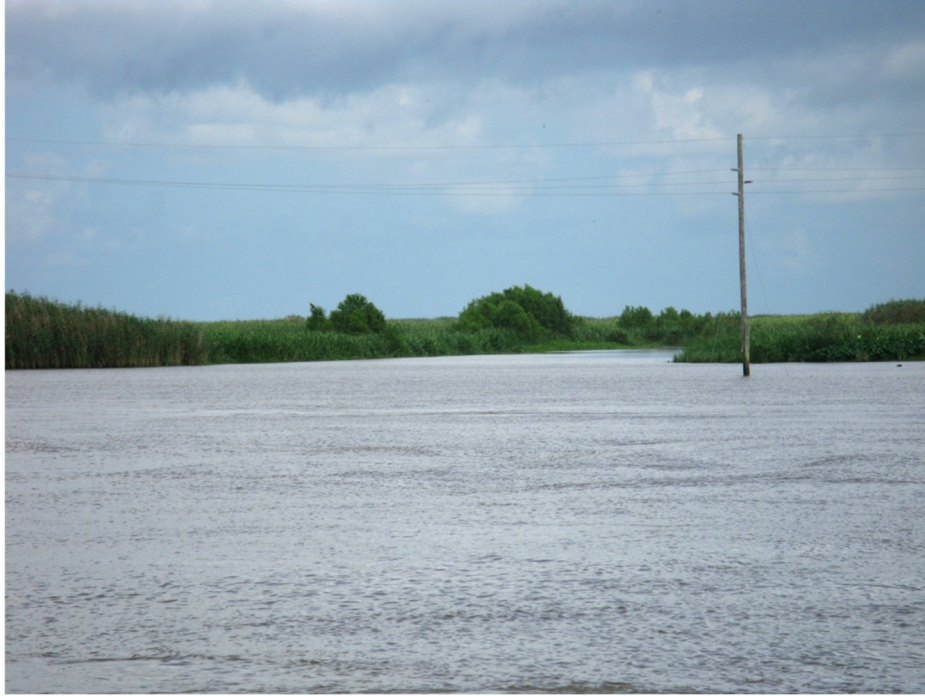
- F. Crevasse No. 81 (2005): (1,200 ft. X 100 ft. X -8.0 ft. NAVD 88) This crevasse was not visited by the inspection team. It is located off Baptiste Collette in the Delta Wildlife Management Area. Conditions from the 2011 inspection are presumed to be the same: "Despite soundings indicating that the mouth of this crevasse has silted up from the large amounts of sediments moving into the cut, there is still some sediments being carried into the interior marsh area. The 3.5' draft of the boat was too deep to travel into the crevasse."

Crevasse No. 81. (2011 Stock Photo). This crevasse location was not visited by the crew.
